Subj: COMMAND INVESTIGATION INTO THE FACTS AND CIRCUMSTANCES
SURROUNDING THE MARINE MEDIUM TILTROTOR SQUADRON 163
(VMM-163) CLASS A AVIATION MISHAP ON 26 AUGUST 2013

Subj: COMMAND INVESTIGATION INTO THE FACTS AND CIRCUMSTANCES
SURROUNDING THE CLASS "A" MISHAP INVOLVING A MV-22B AT
CREECH AIR FORCE BASE, NEVADA ON 26 AUGUST 2013

PRELIMINARY STATEMENT

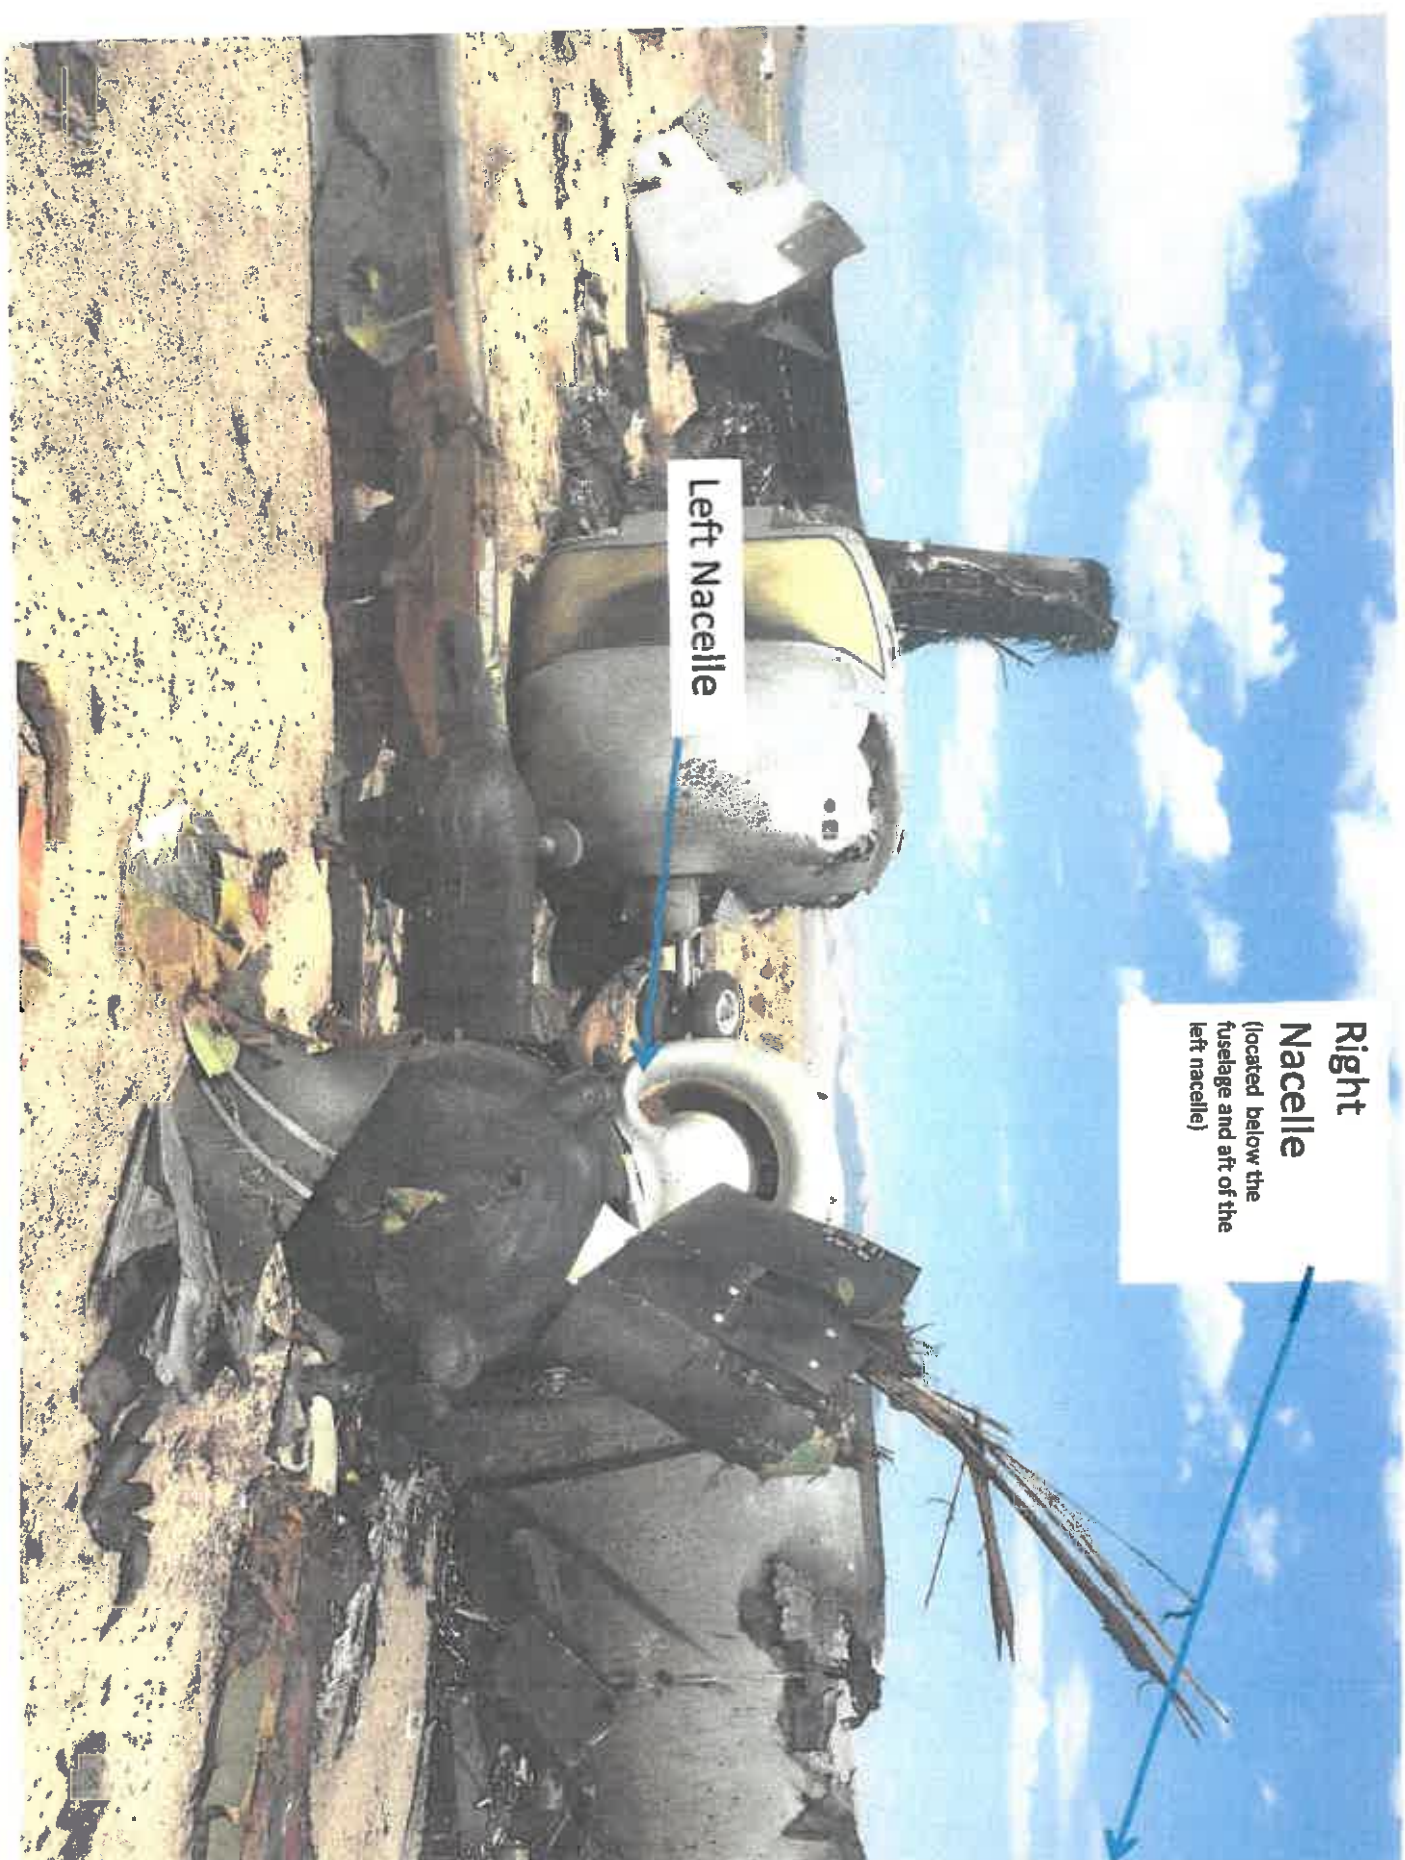
Right Nacelle
(located below the fuselage and aft of the left nacelle)

Left Nacelle
